AmeriSpec Home Inspections

Property Inspection Report

**123 Main St.
Anywhere, USA**

Date: 01/01/2010
Inspection # 123456789
Client Name John Doe
Address Anywhere, USA

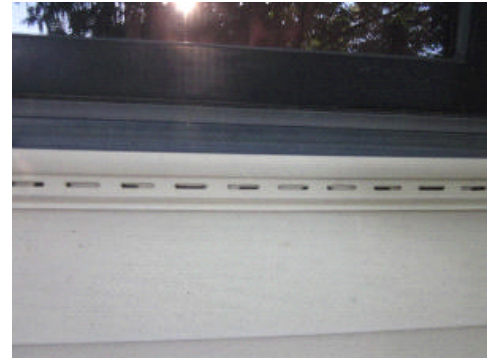
Vinyl.
 Gap noted in the siding at the upper right front corner of the home.
 Repair as needed.

Vinyl.
 Missing trim noted under the front window. Repair as needed.

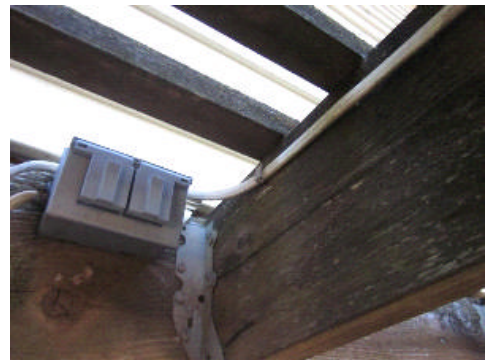
158 ELECTRICAL:

SAFETY CONCERN Loose hanging or otherwise exposed wires noted. Wiring must be properly secured and protected from damage. Recommend securing. Loose outlet noted. **REPAIR** as needed by qualified electrician

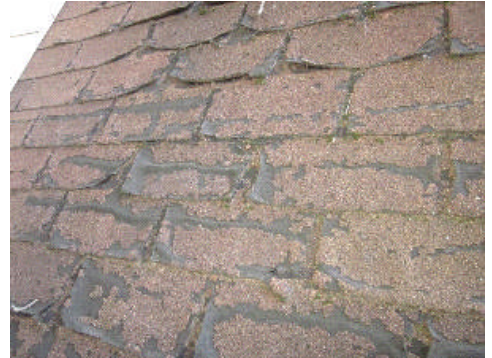
233 ROOF COVERING STATUS:

Roof shows signs of significant granular loss, curling. Areas of damaged/missing shingles noted with exposed sheathing noted. Roof is at the end of its useful life. Suggest further review and repairs/replacement by a qualified roofer.

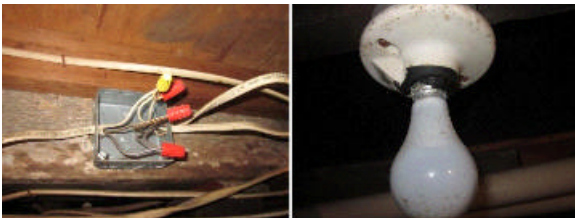
SAFETY CONCERN Several open junction boxes noted. Whenever a wire is cut and re-connected, the "splice" should be encased in a covered junction box to prevent shocks and separation of the splice. SAFETY CONCERN Open wiring splices noted. ANY TIME WIRES ARE CONNECTED, THE CONNECTION MUST BE IN A PROPER JUNCTION BOX. Damaged light fixture noted at the floor joist. Repair as needed by qualified electrician.
